AFFDL-TR-72-64

DEVELOPMENT OF AN UNDERSTANDING OF THE FATIGUE PHENOMENA
OF BONDED AND BOLTED JOINTS
IN ADVANCED FILAMENTARY COMPOSITE MATERIALS

VOLUME III. FATIGUE ANALYSIS AND FATIGUE MODE STUDIES

A. C. Fehrle, J. R. Carroll, S. M. Freeman, et al.
Lockheed-Georgia Company
Marietta, Georgia

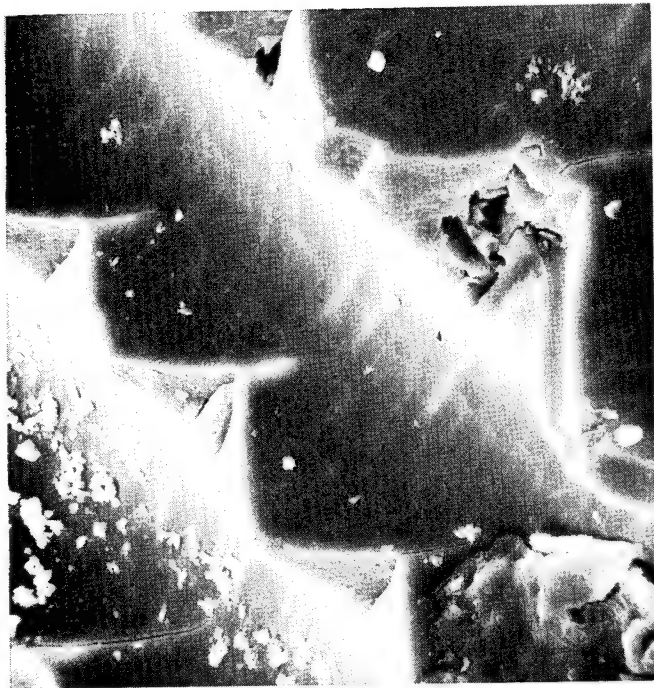
The 52X magnification, Figure 79, of specimen -E06 shows the general appearance of the failed surface whereas the 575X magnification of the same failure surface shows finer details of the fracture mode. The saw tooth effect so prominent in these photos indicates that the reversal in specimen loading resulted also in the reversal of principal tension stress within the resin causing the tensile failures. This fracture mode differs from the basic shear mode as evidenced on the flexure specimen. On the flexure specimen the tensile fractures were in one direction and were not as sharply defined whereas on this $R = -1.0$ fatigue failure the fractures are sharp, well defined, and the tensile fractures are nearly normal to each other. The 50X magnification, Figure 80, of specimen -E02 shows the general appearance of the failed surface whereas the 500X magnification of the same failure surface shows details of the fracture mode. The tensile fracture that was defined in the flexure specimen as a shear mode is also illustrated in this photograph. However, the fracture for this specimen has a rounded appearance along the length of the tension fracture indicating the direction of the principal tensile stress is varying through the thickness of the resin.

- NOTES: 1) Arrows A indicate filament of woven adhesive carrier (scrim).
 2) Arrows B indicate glass scrim cloth used with the boron-epoxy tape.
 3) Area shown at 575X is similar to that enclosed by circle (c).
 Notice topographical features (cracks) of resin matrix that was adjacent to boron filaments.

Figure 79 Typical View of Fracture Surface "A" in Adhesive Bonded Joint Specimen

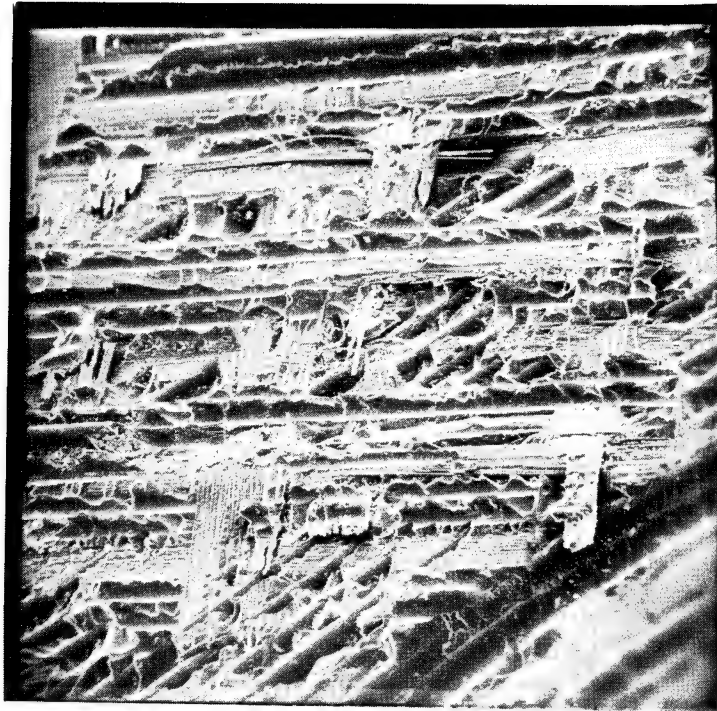
Figure 97 IA113A01 Failure Surface "A"
53X Magnification
(Reference Figure 96 Upper Left)

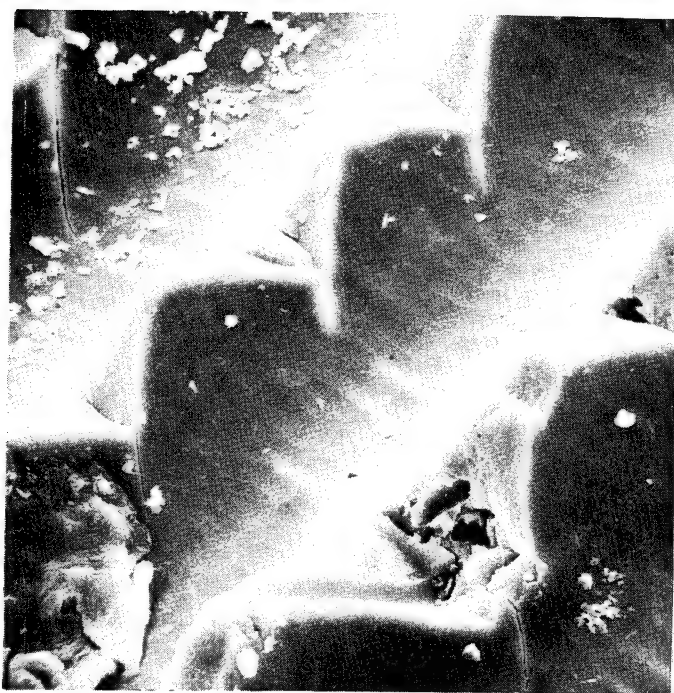
Figure 128 Shear Failure in Matrix Subjected to a Stress Ratio of $R = -1.0$

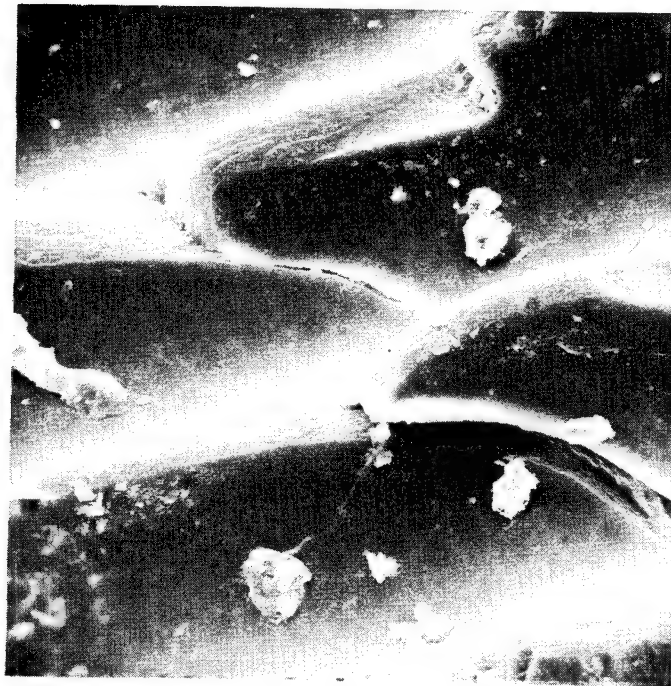
Figure 130 Shear Failure in Matrix Subject to Compression-Compression Fatigue, $R = +10.0$
